**NESHAP BUILDING INSPECTION  
FOR  
ASBESTOS-CONTAINING MATERIALS**

**Erie County Community College  
2403 West 8th Street  
Erie, PA 16505**

**Work Order No.: F4H0459**

**Date of Inspection: 8/12/2024 & 8/16/2024**

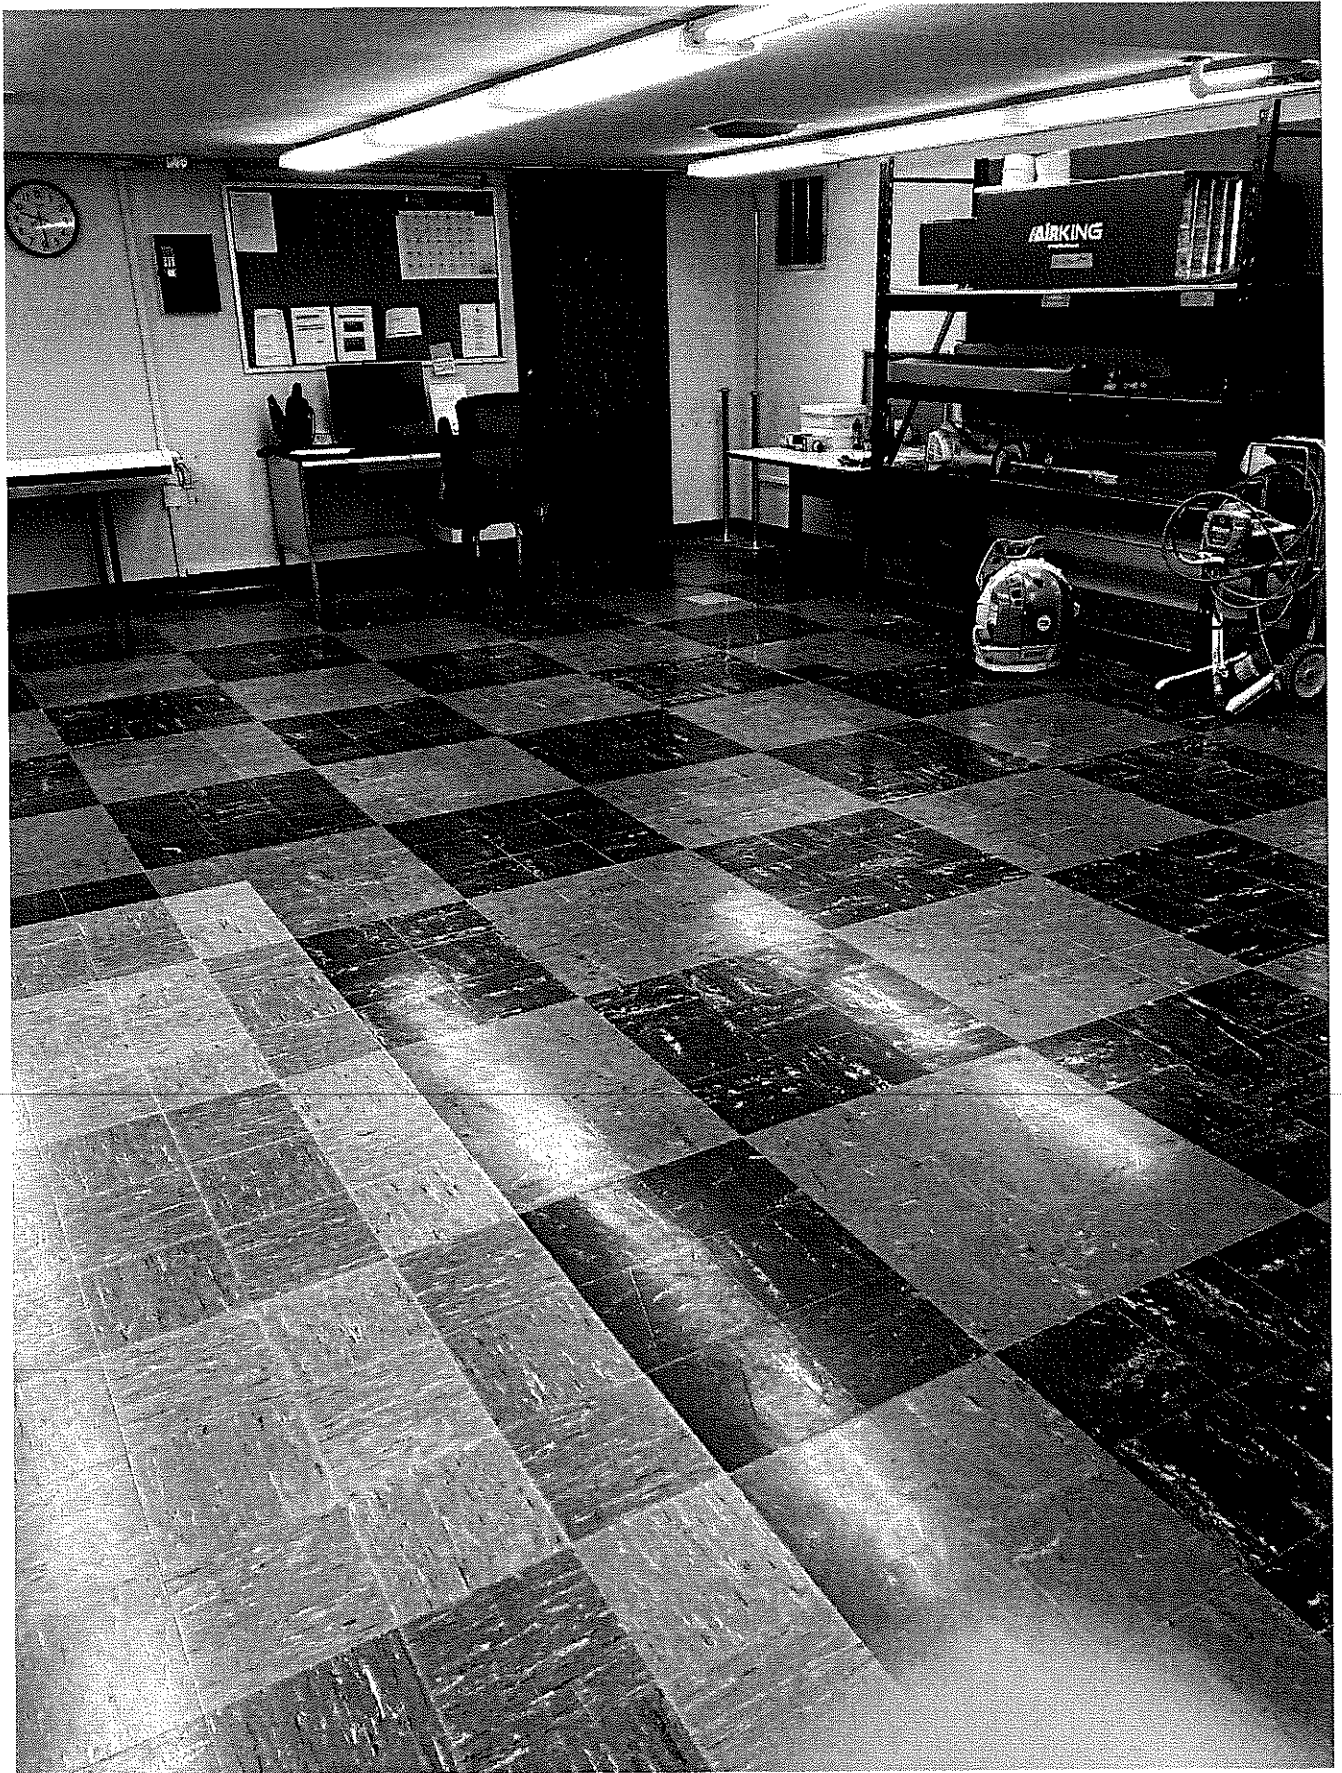
Typical Classroom Flooring (original) - Positive

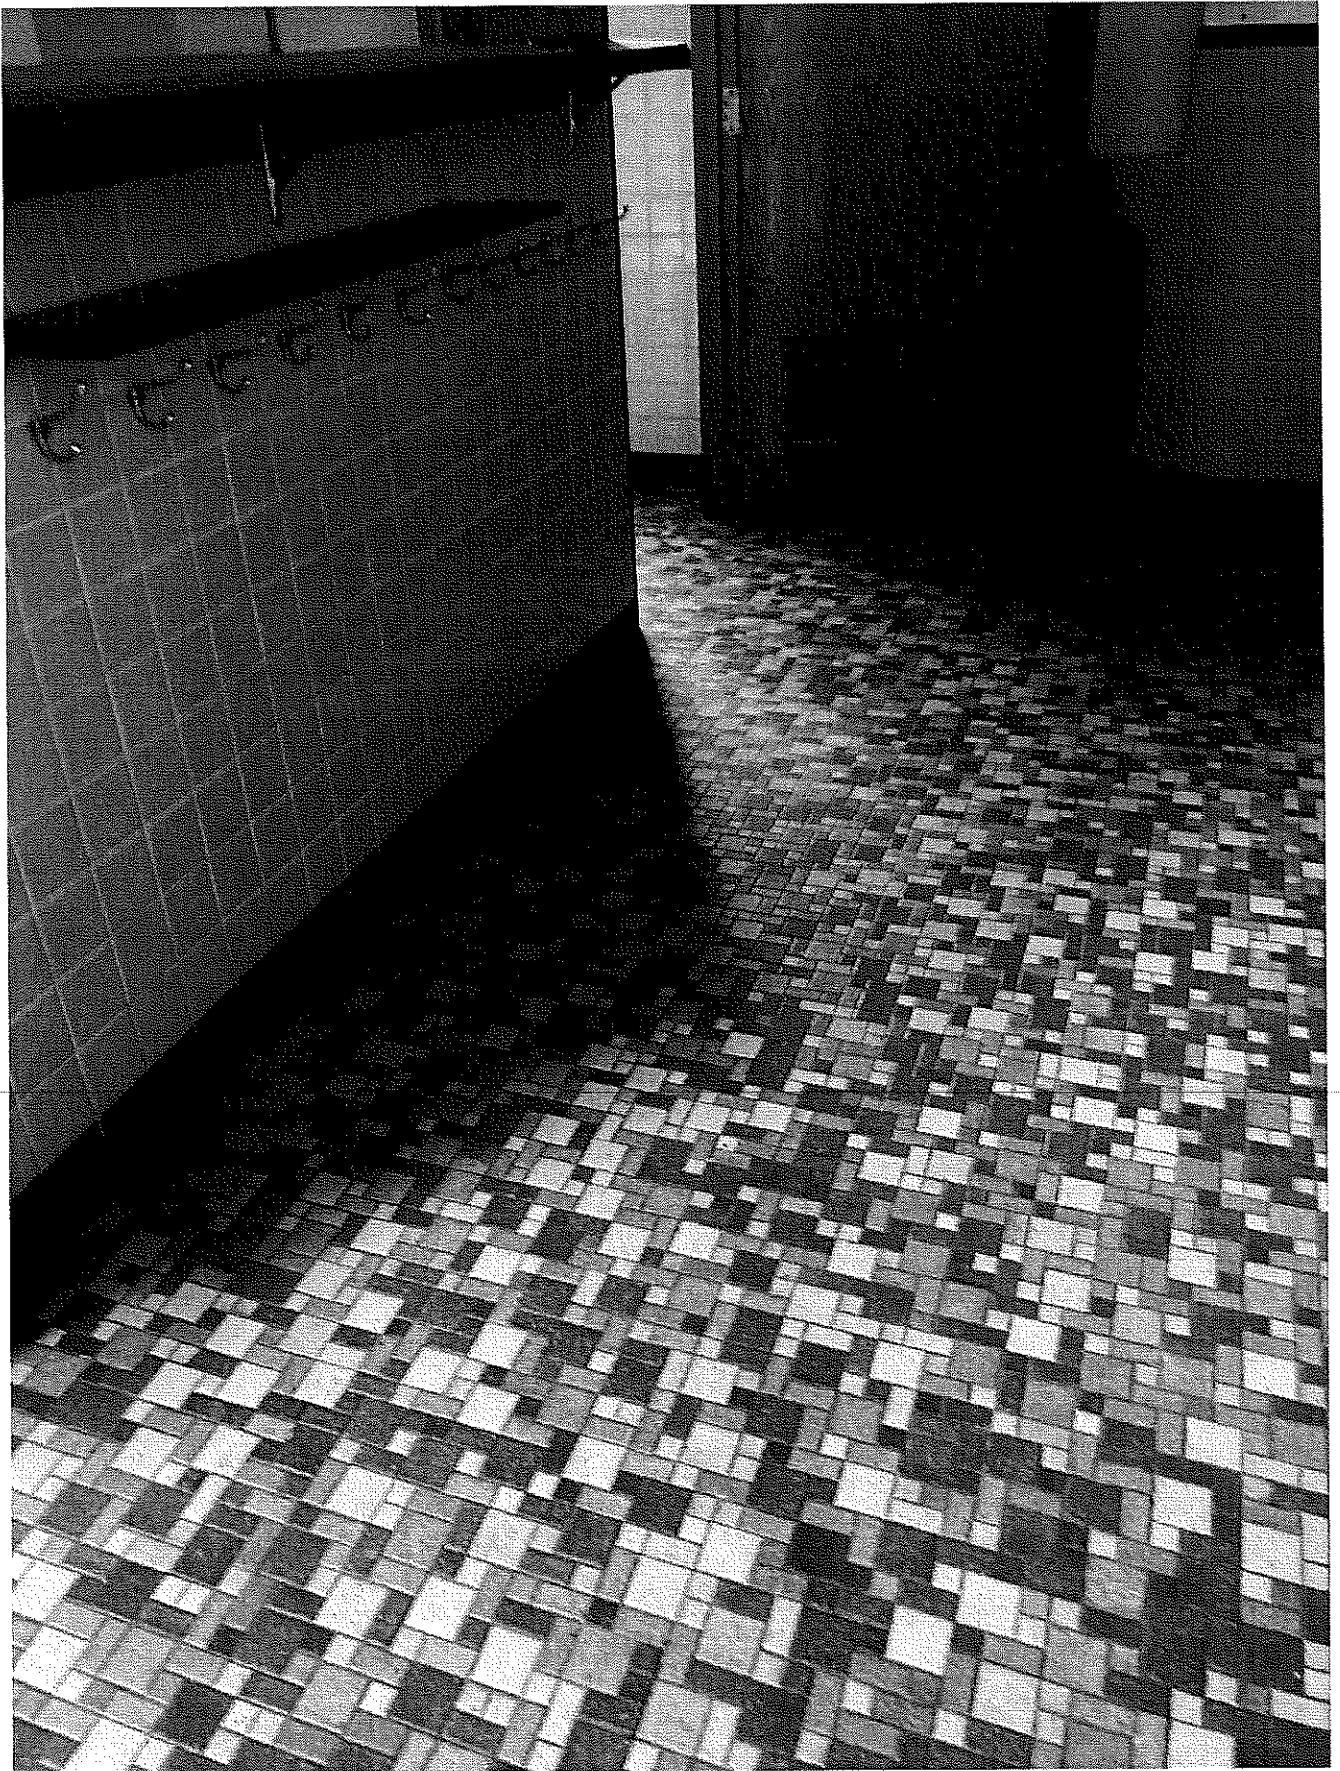
Ceramic Tile Flooring - Negative

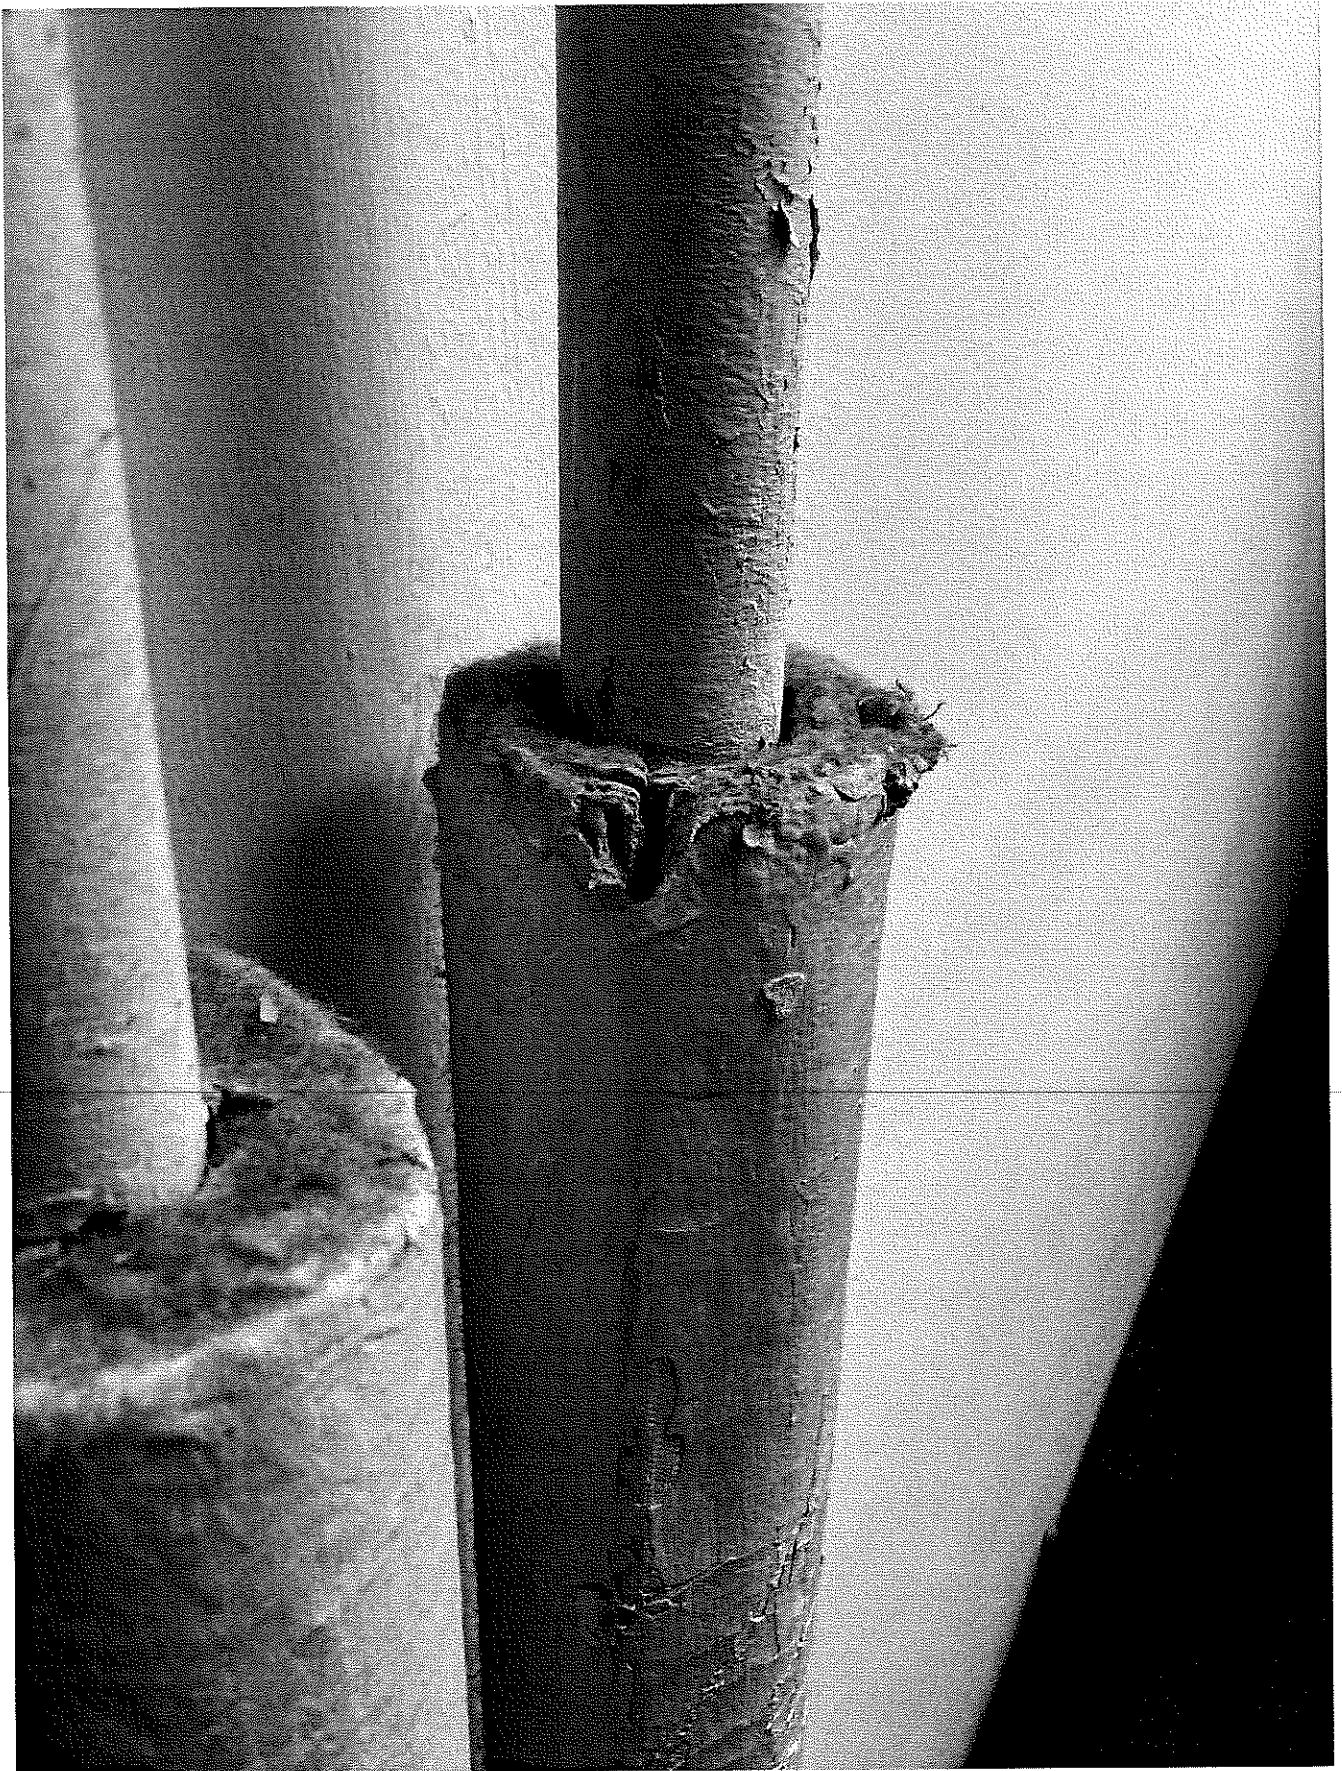
Aircell Pipe Insulation on Heating Lines

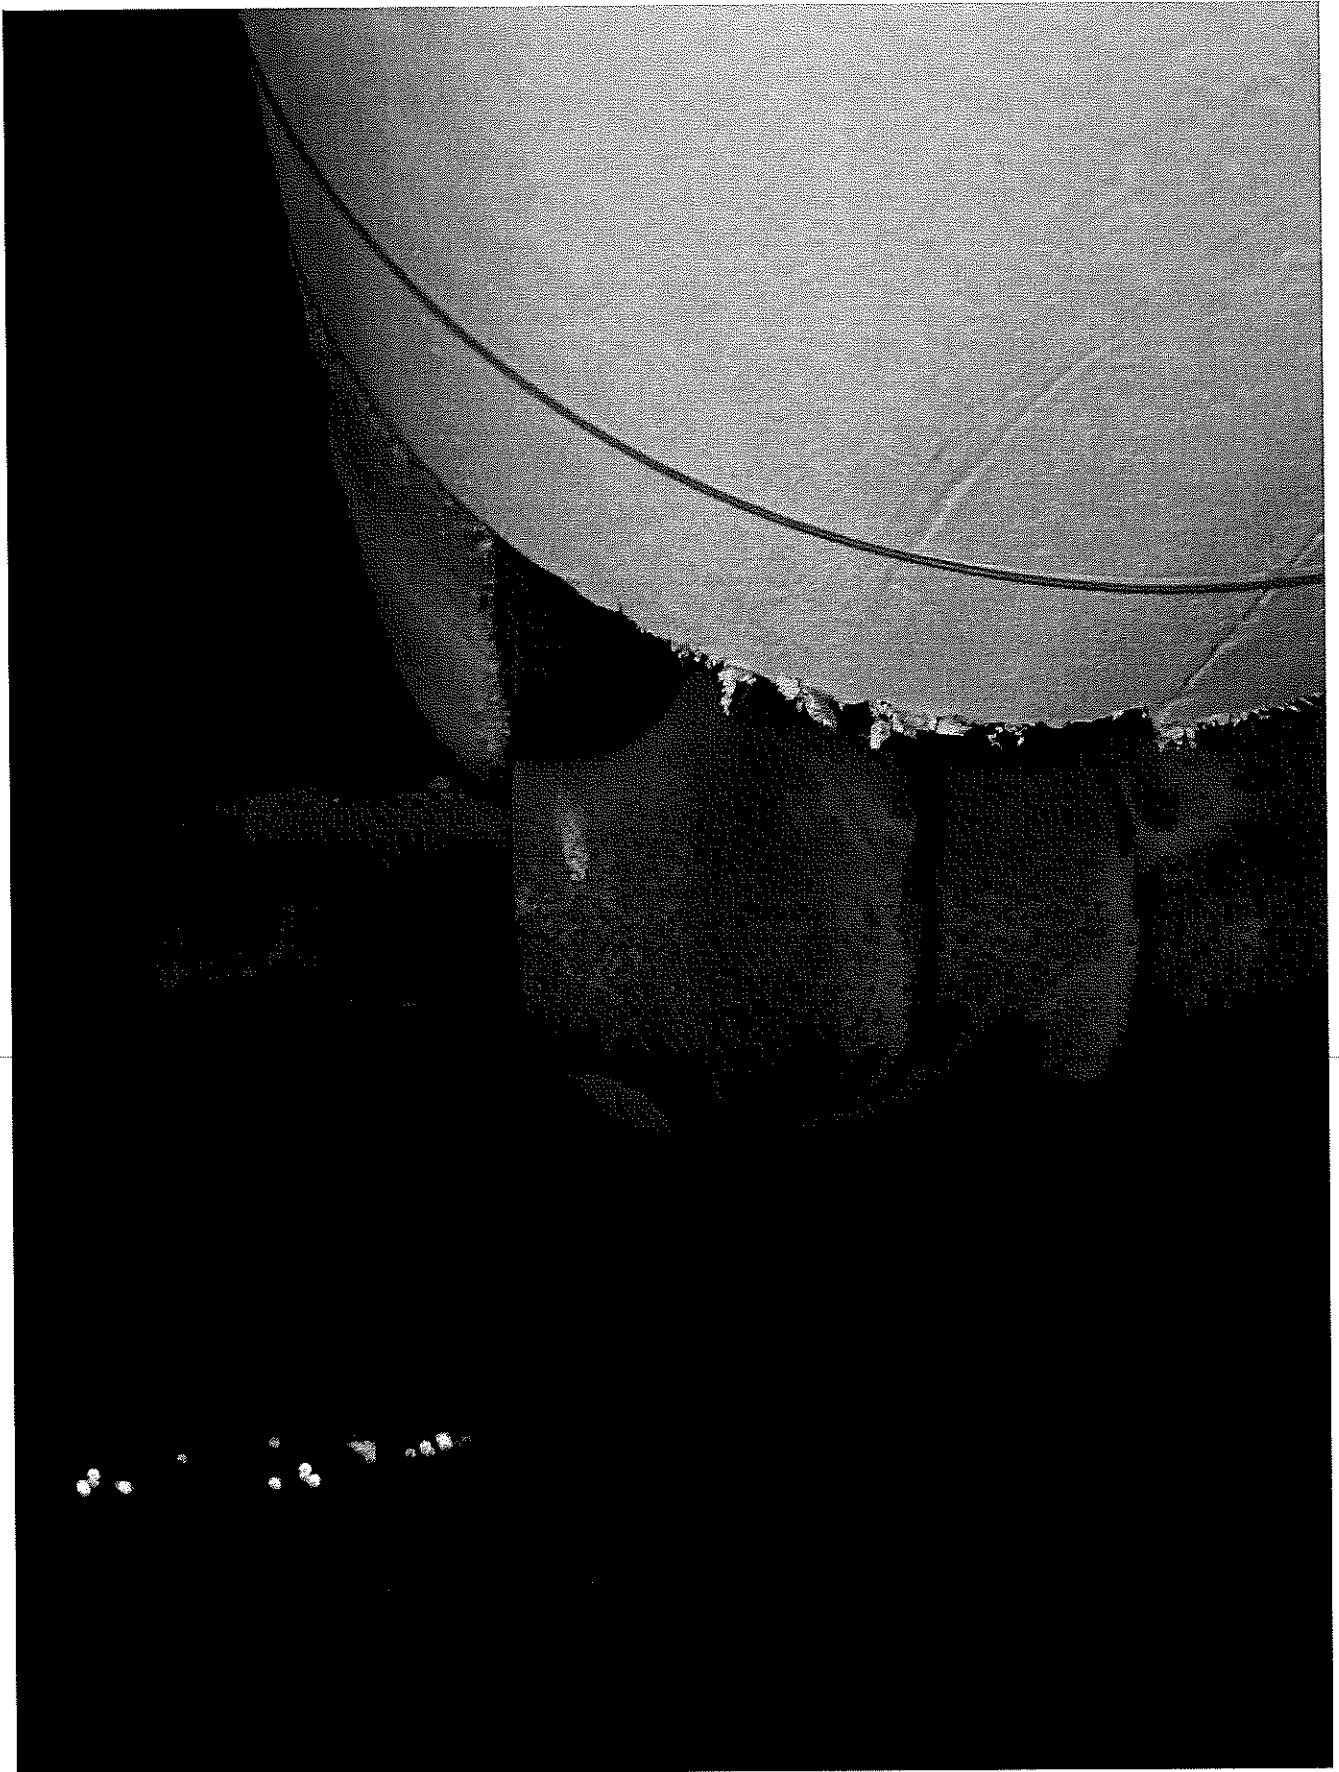
Mag Insulation on Steam Line

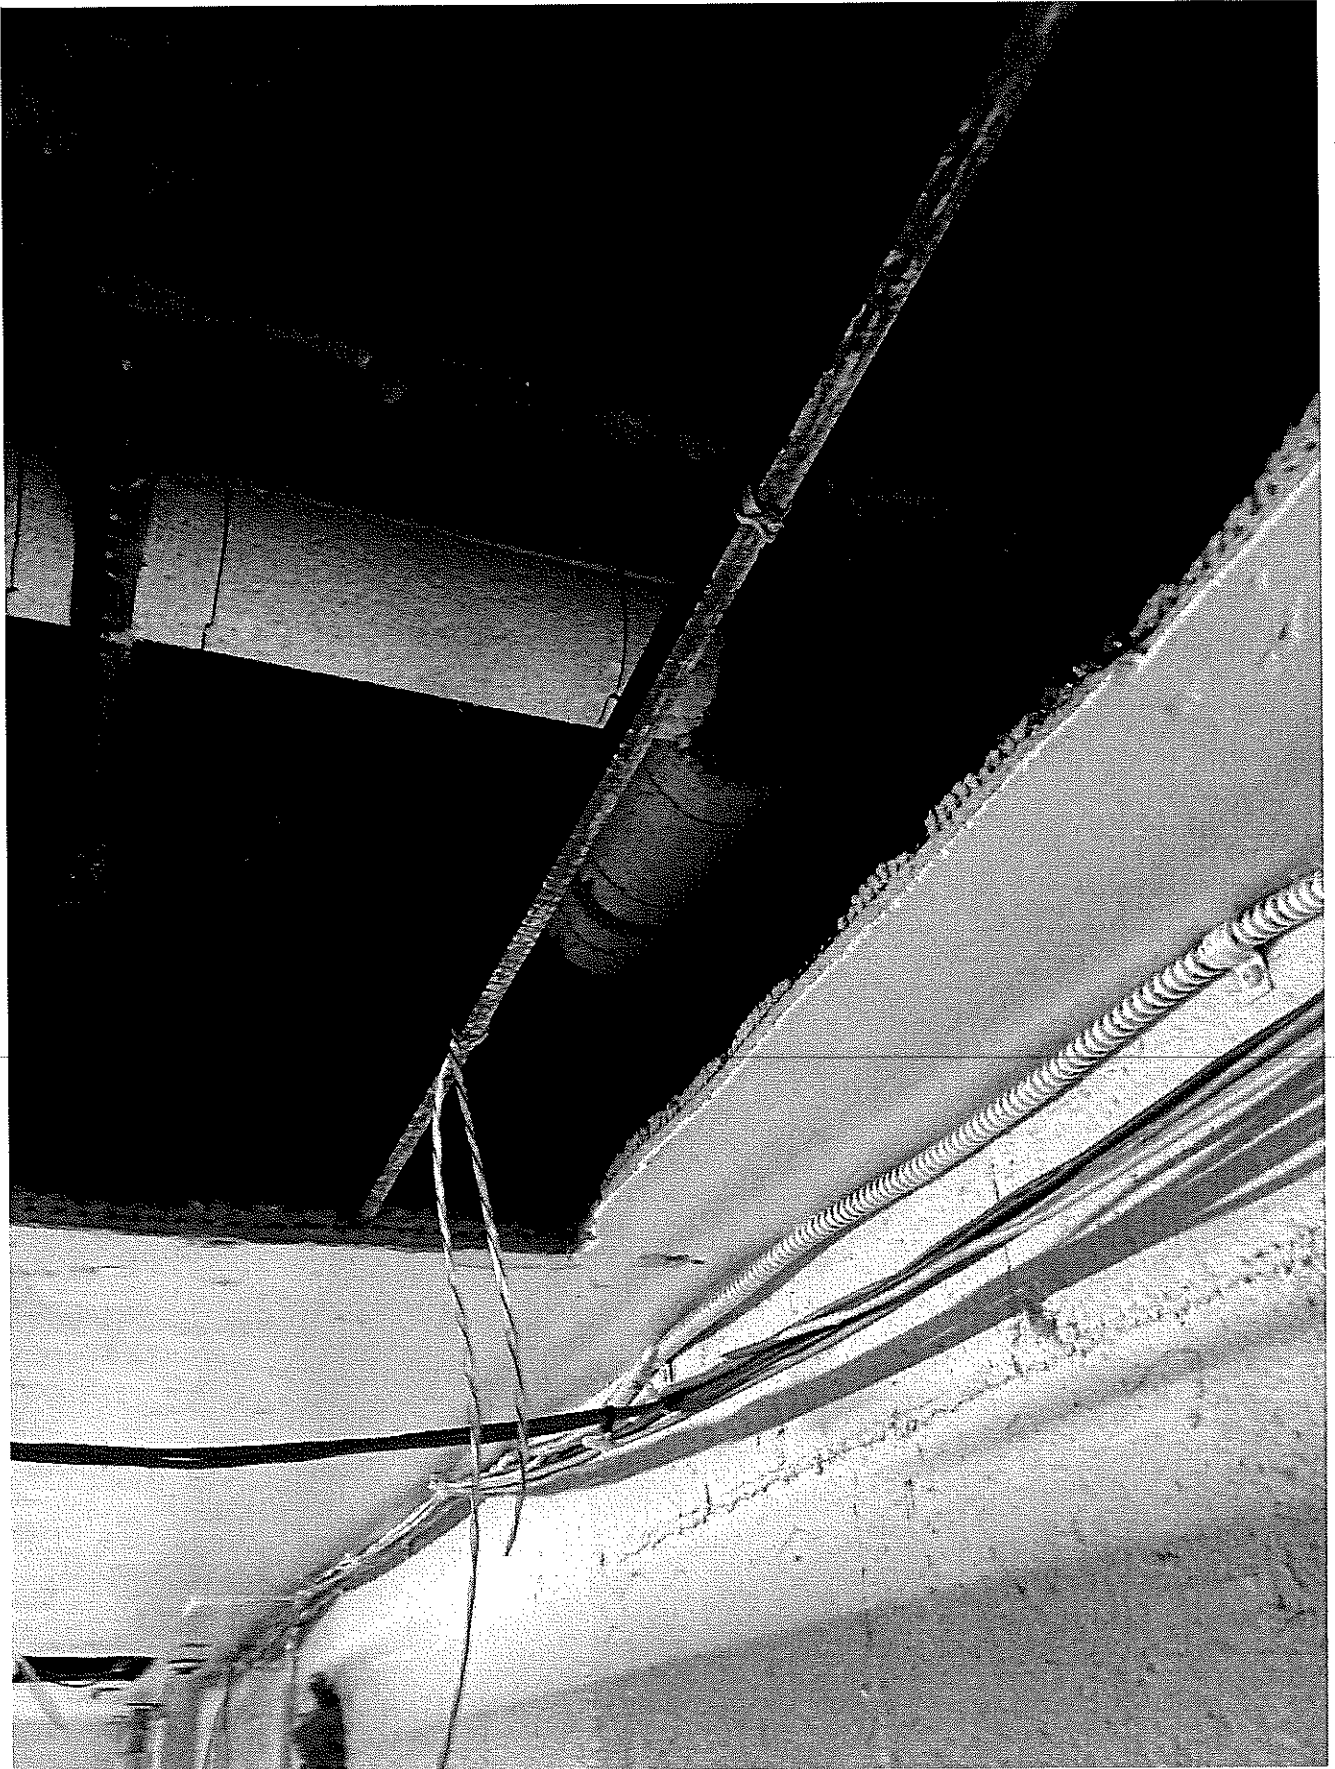
Pipe Insulation Above Ceiling

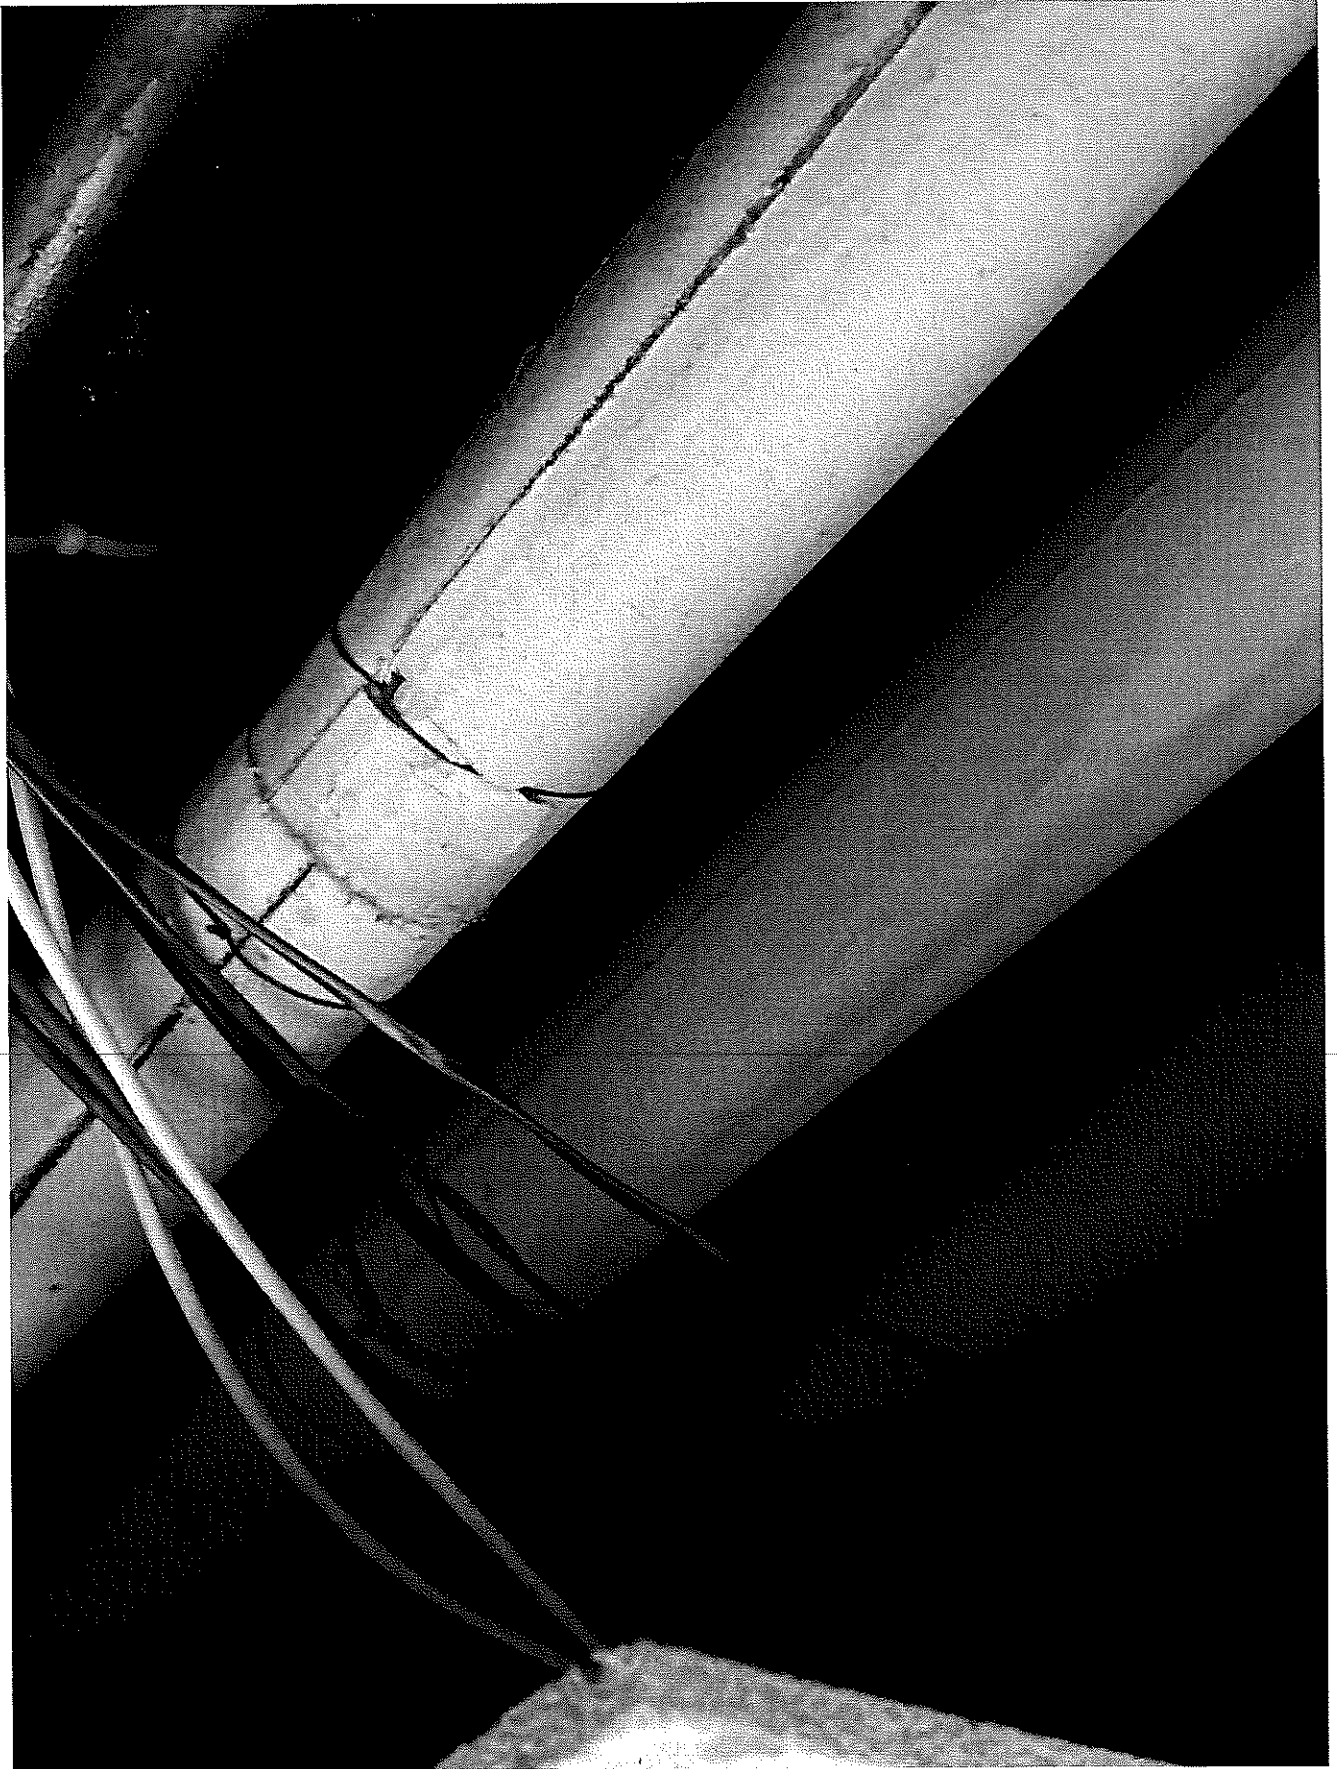
Aircell Pipe Insulation

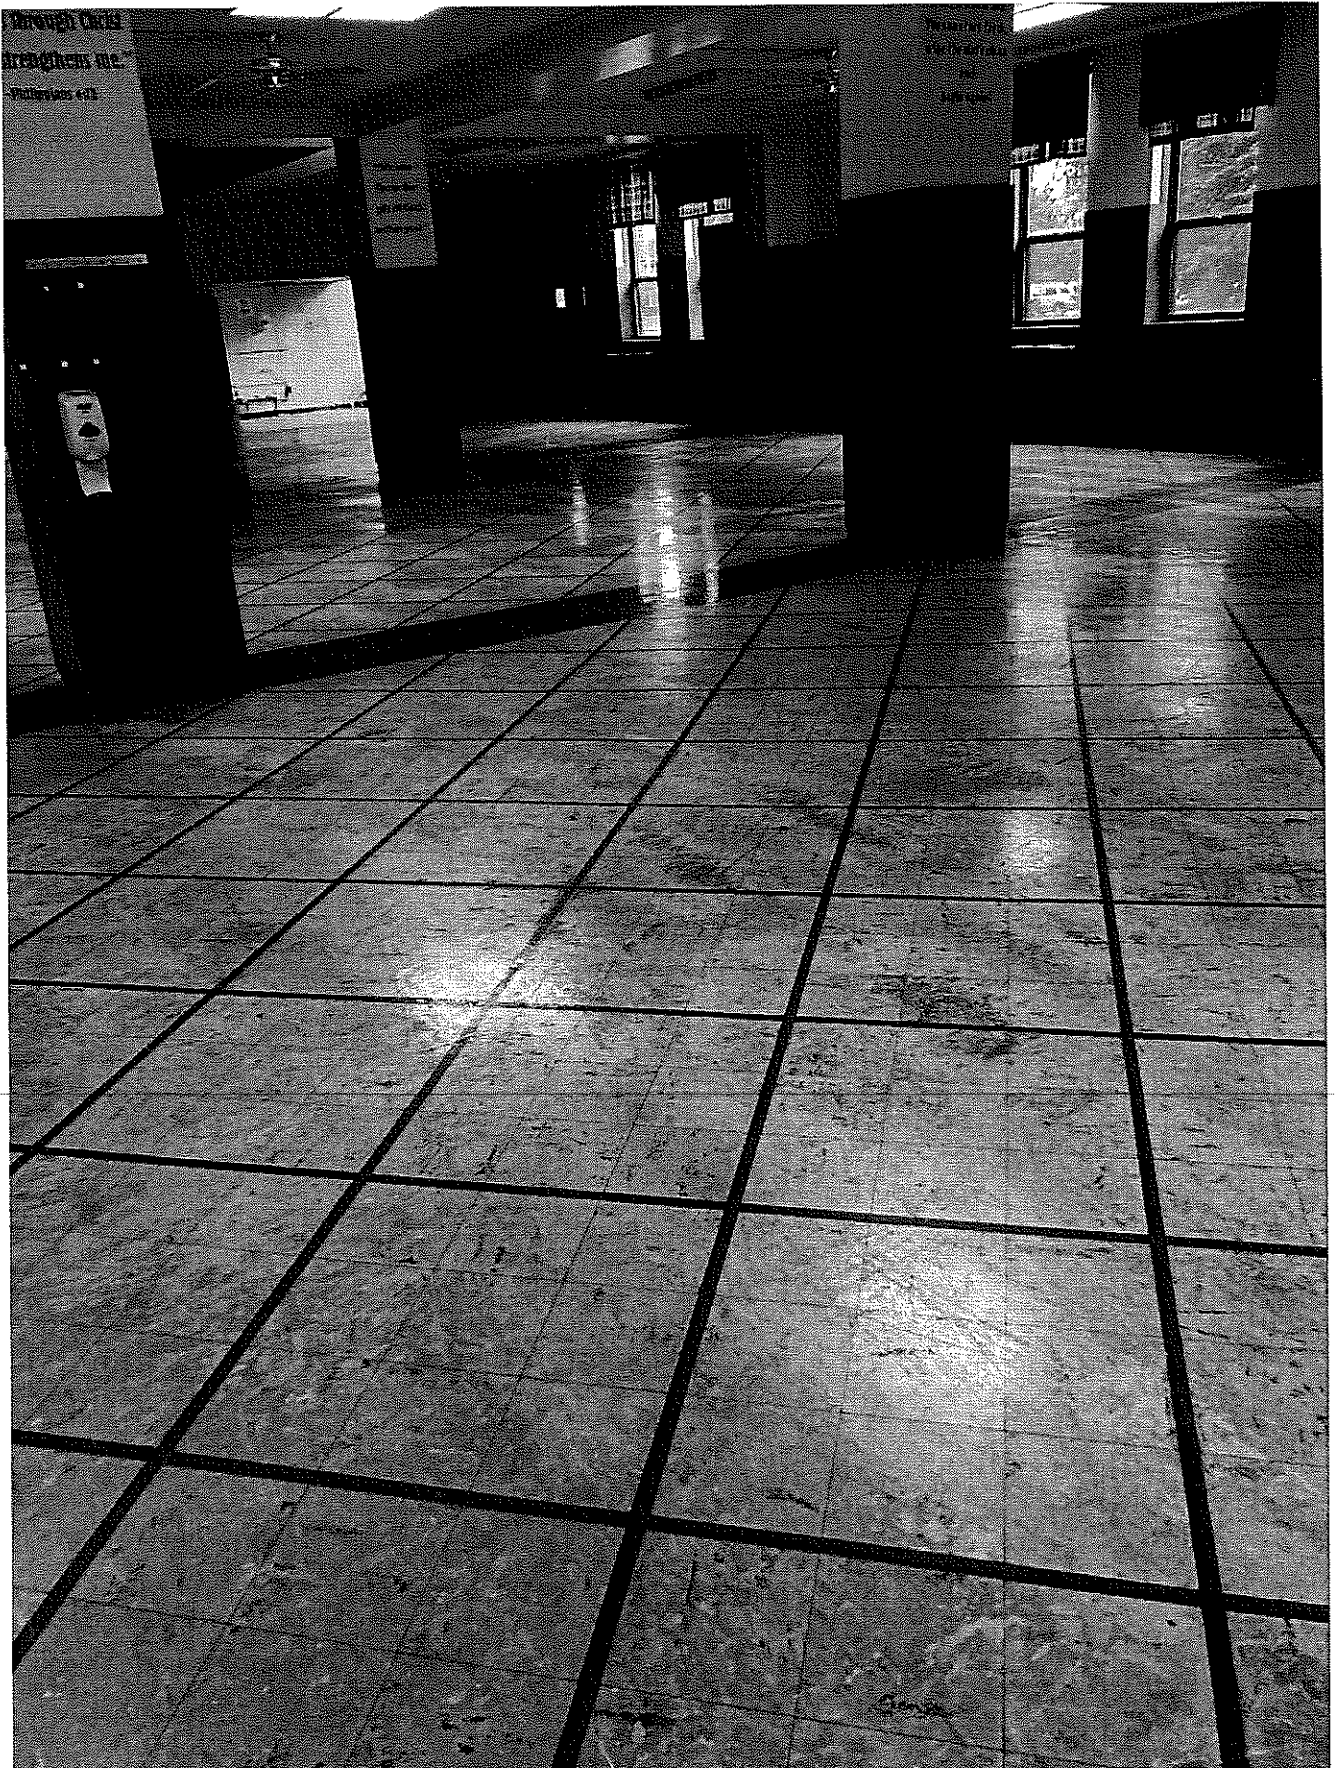
Cafeteria Floor and Border Tile

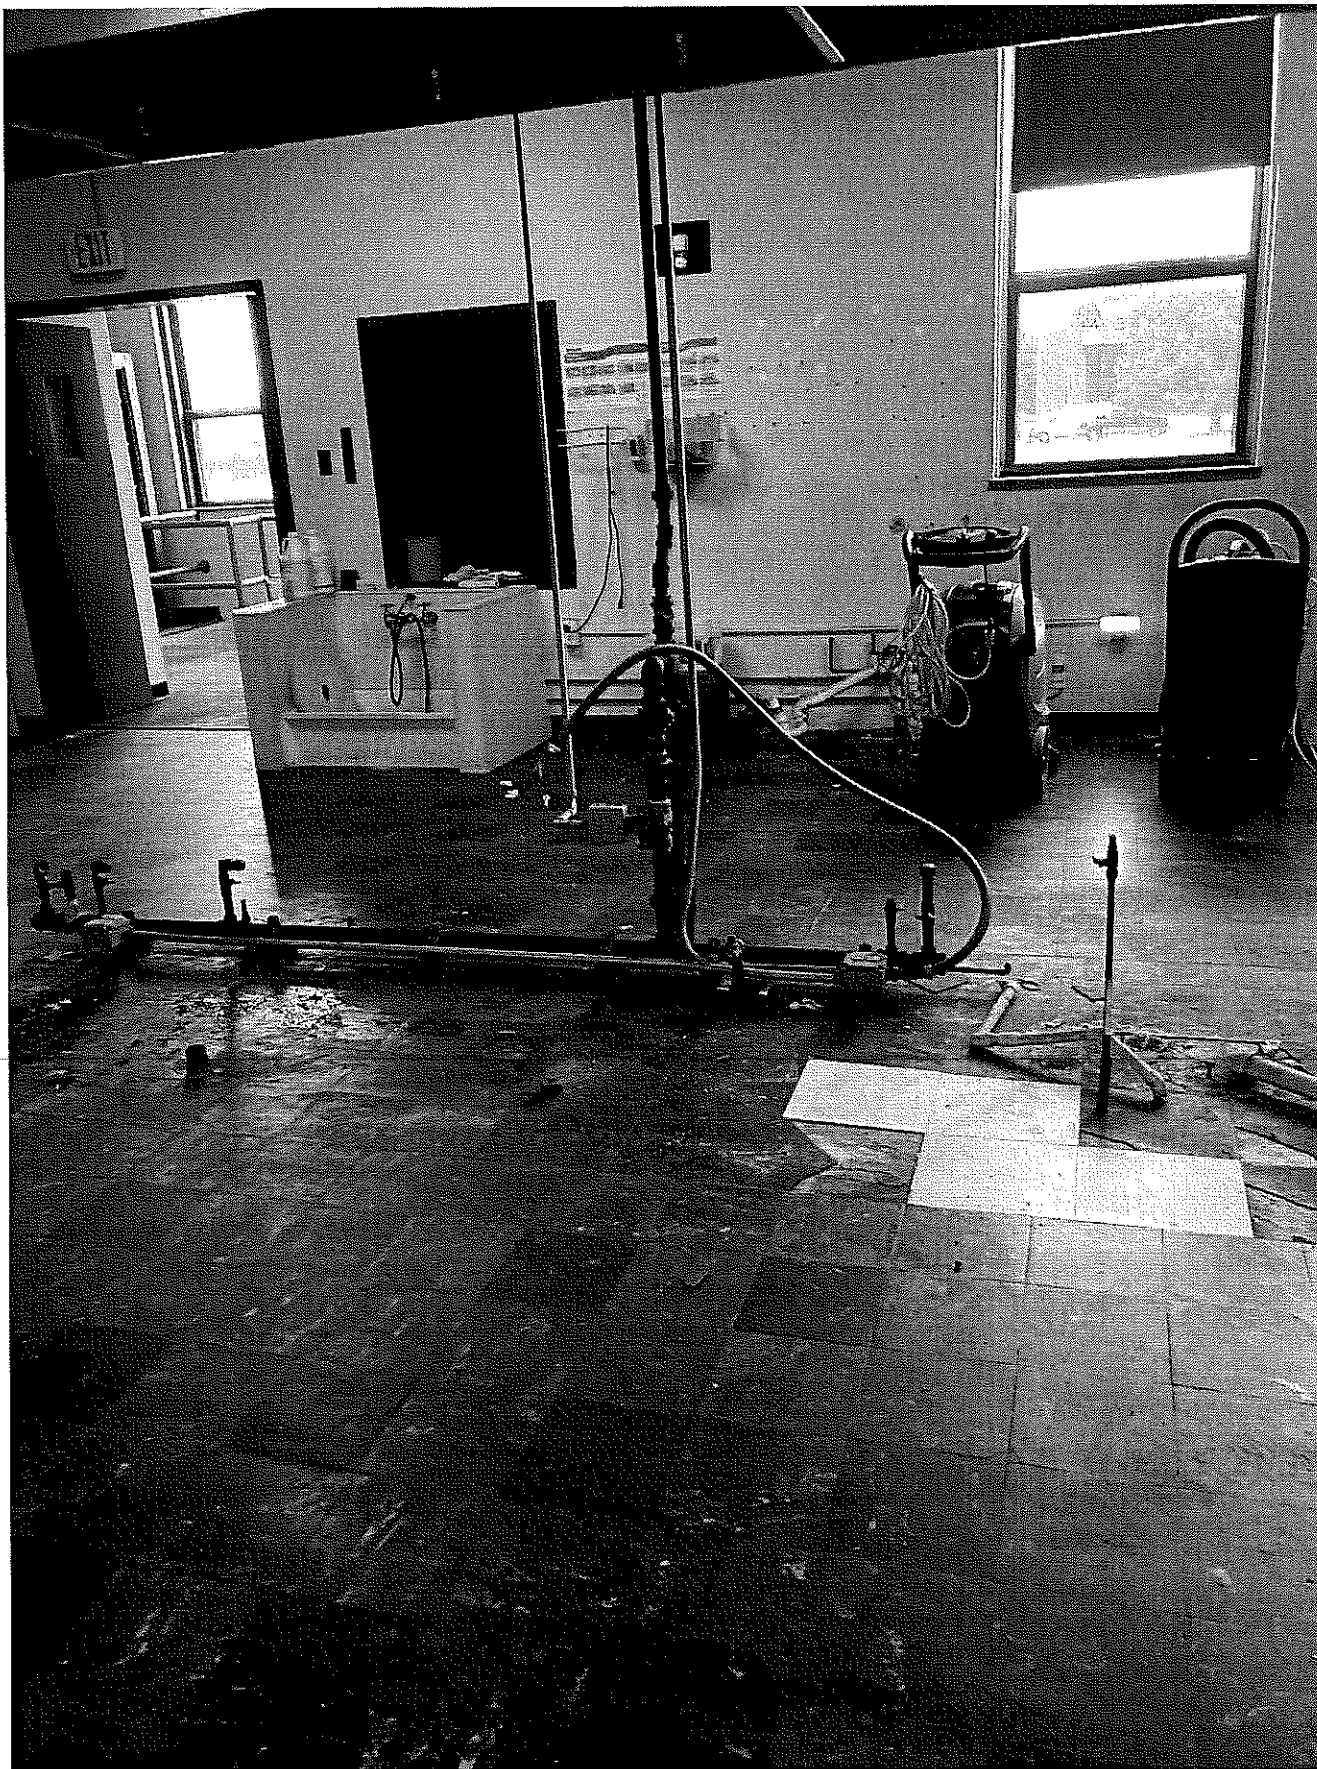
Kitchen Area Floor

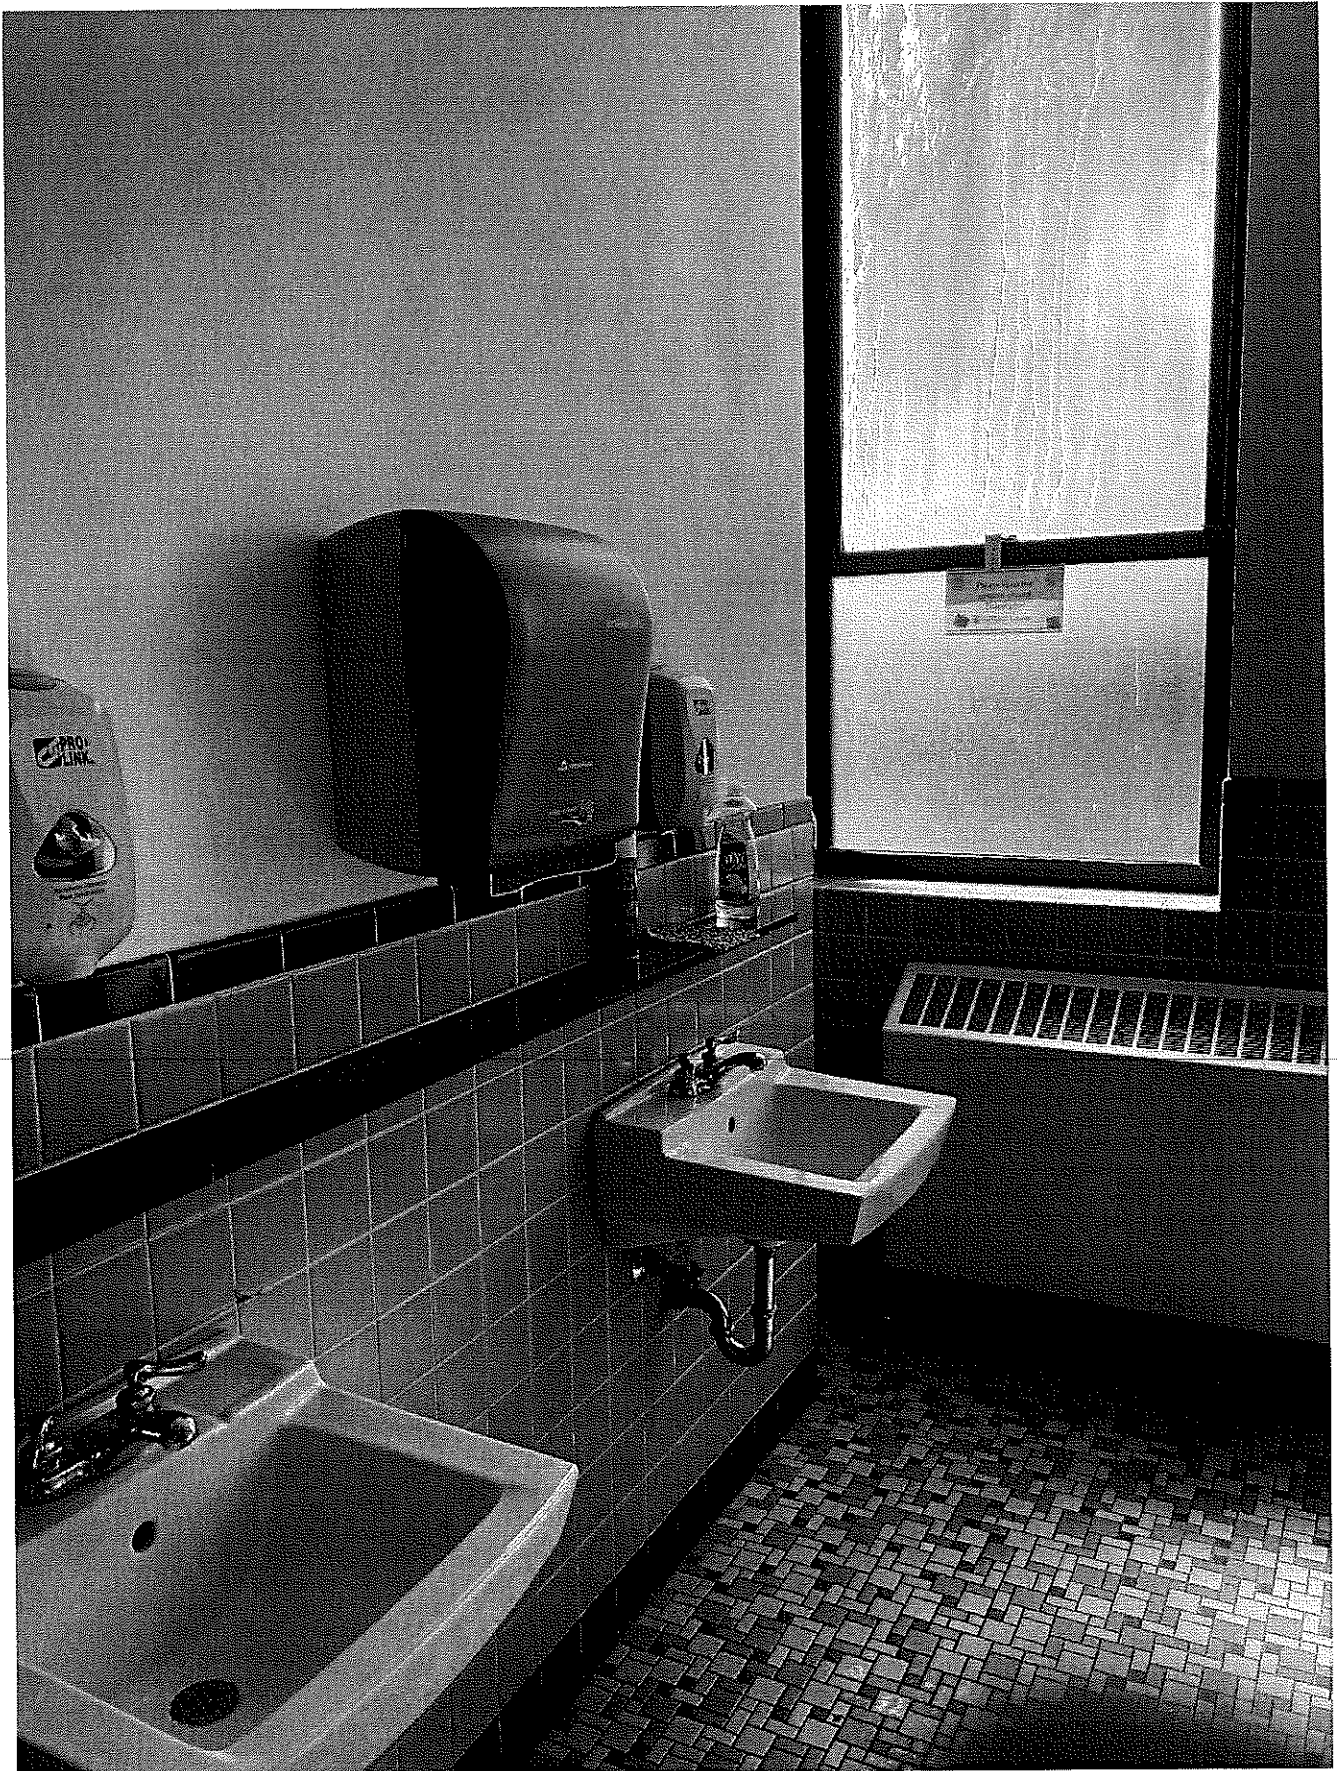
Restroom Ceramic Tile
