**NESHAP BUILDING INSPECTION  
FOR  
ASBESTOS-CONTAINING MATERIALS**

**Erie County Community College  
2403 West 8th Street  
Erie, PA 16505**

**Work Order No.: F4H0459**

**Date of Inspection: 8/12/2024 & 8/16/2024**

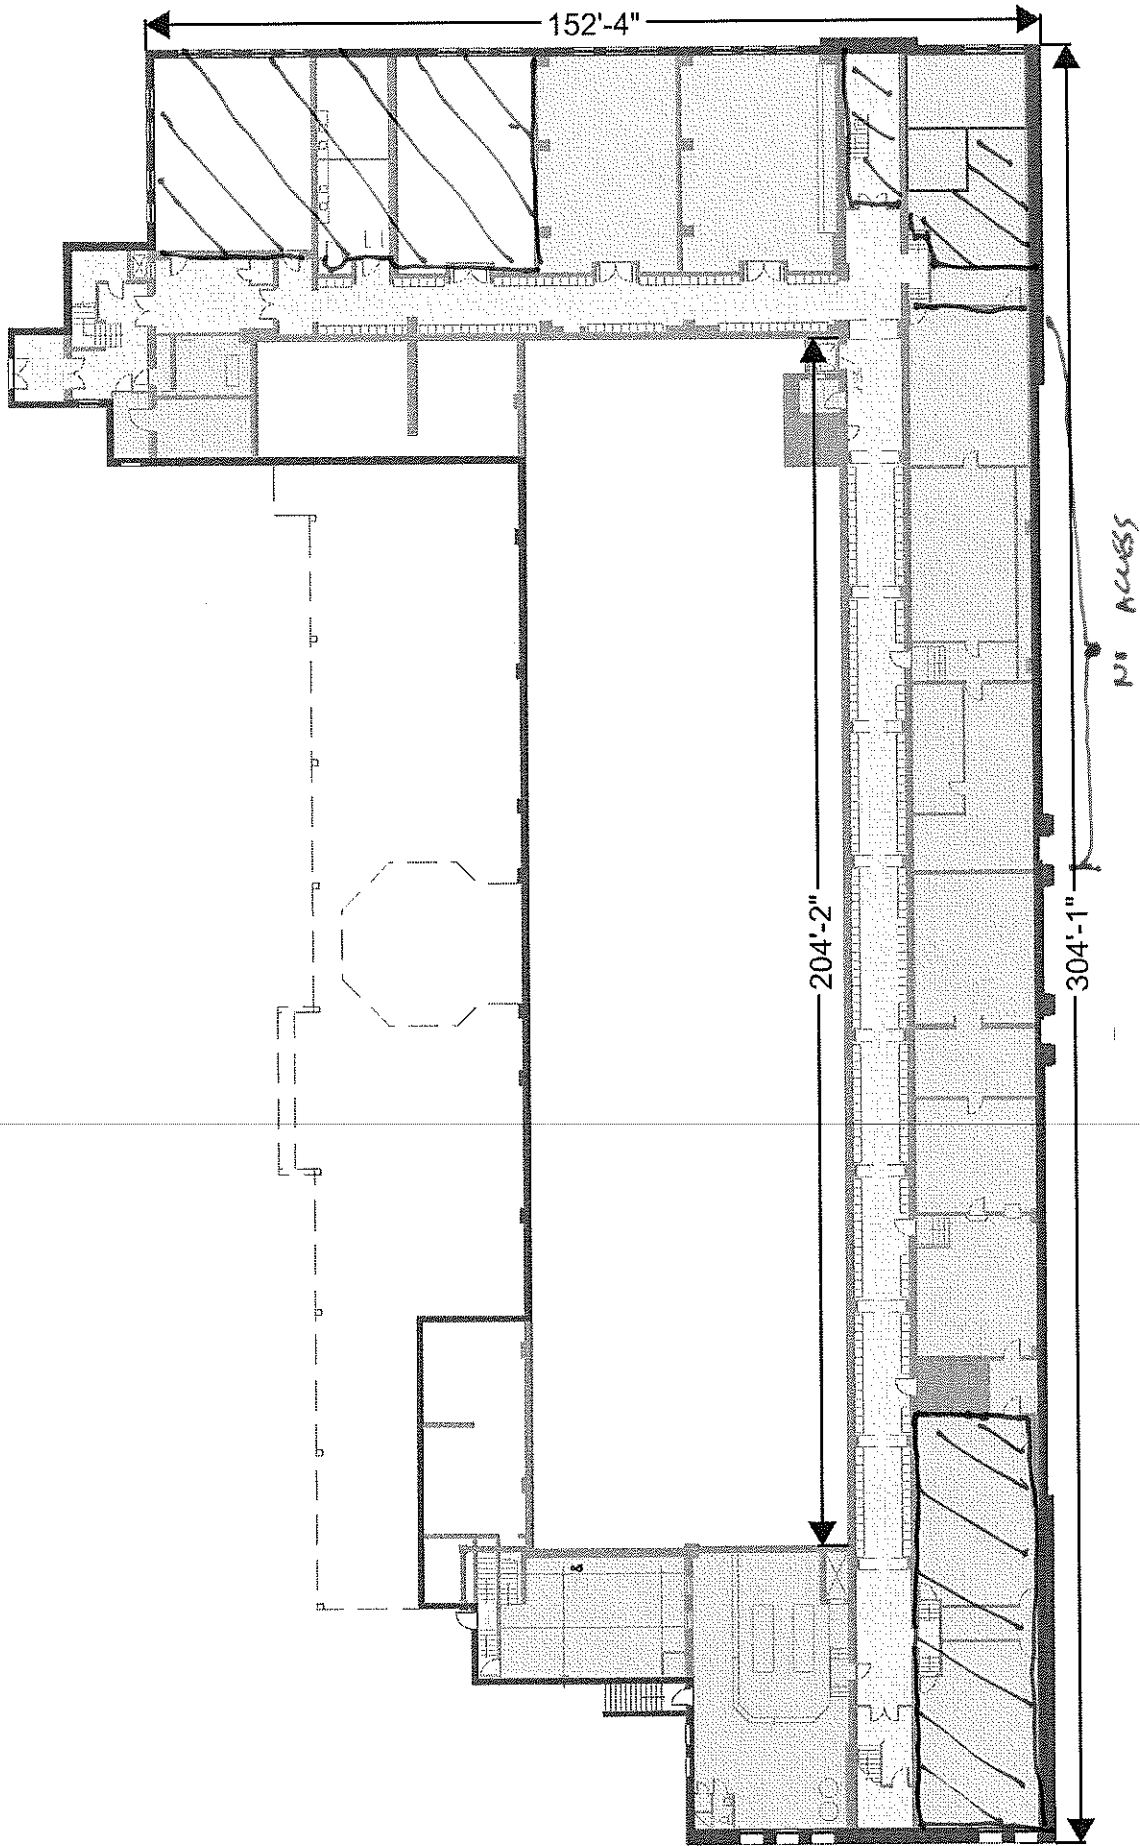
Erie county Community College (west)  
2403 West 8th Street, Erie PA 16505  
**Basement Level**  
NOT TO SCALE  
Prepared by: Chris Ray 1/2/24

VAT LOCATIONS - ACCESSIBLE ROOMS = [Symbol]

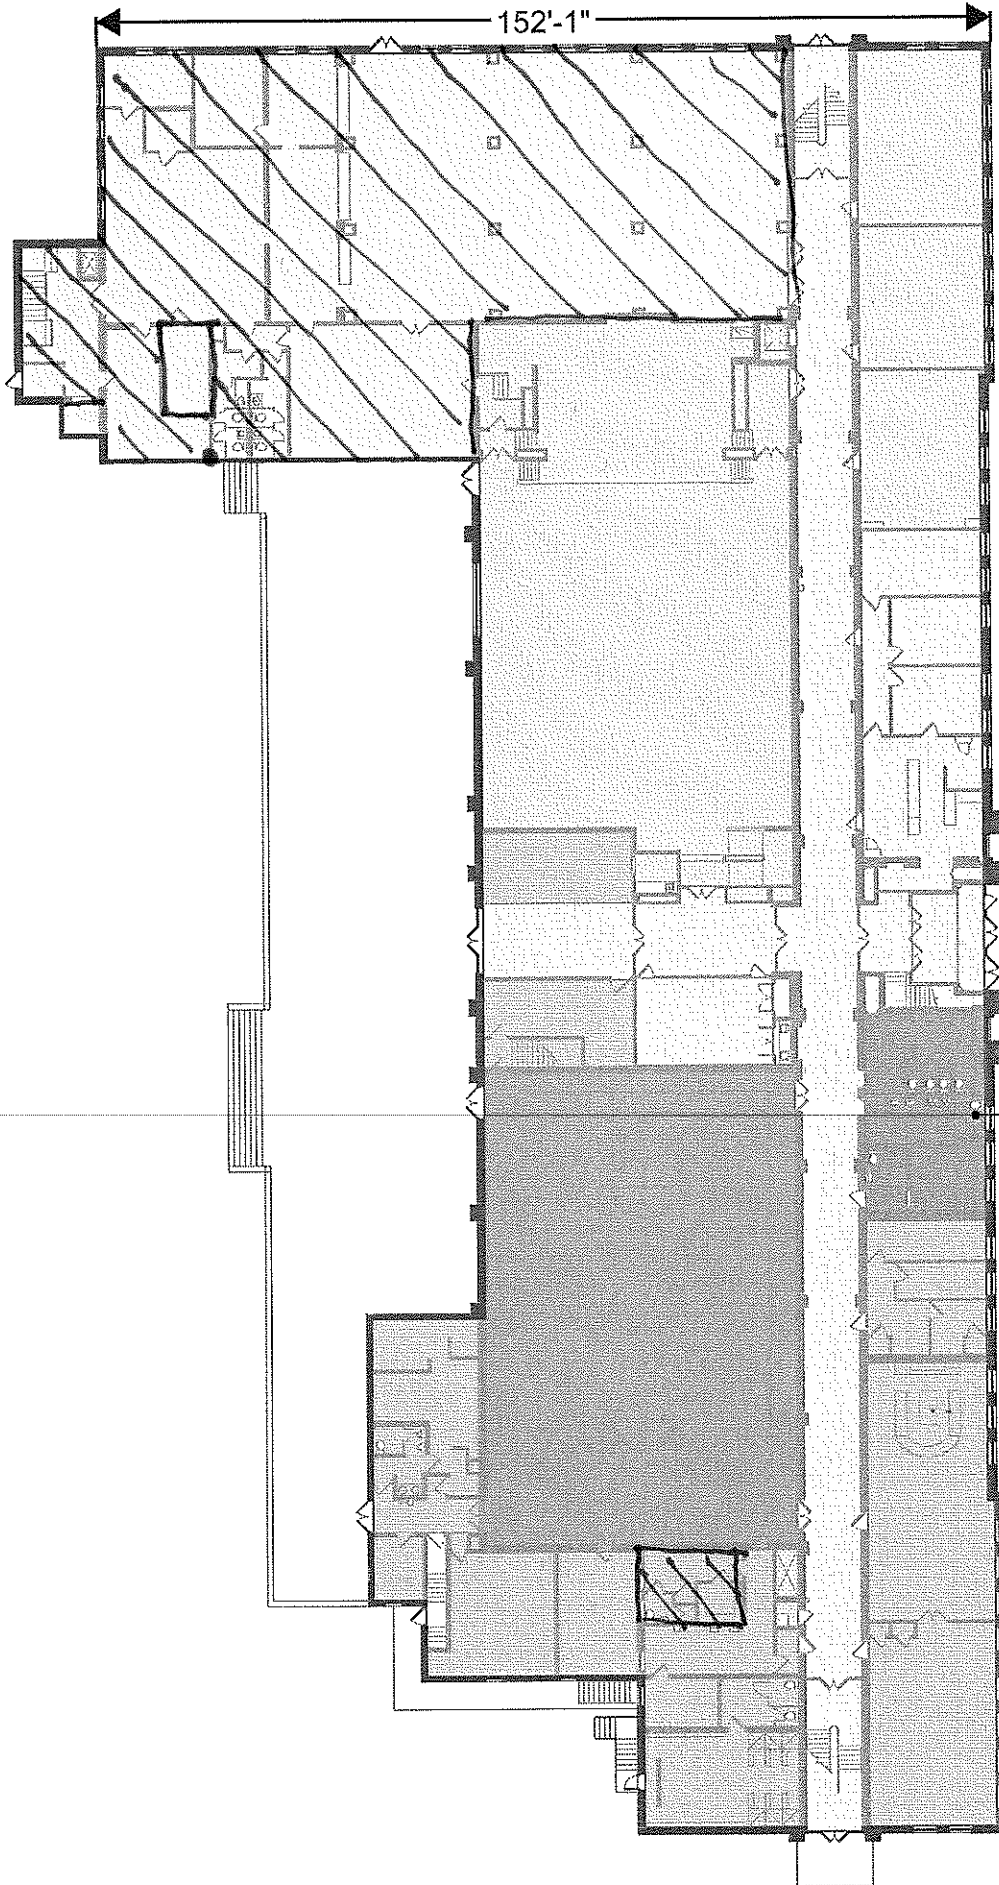
VAF LOCATIONS =

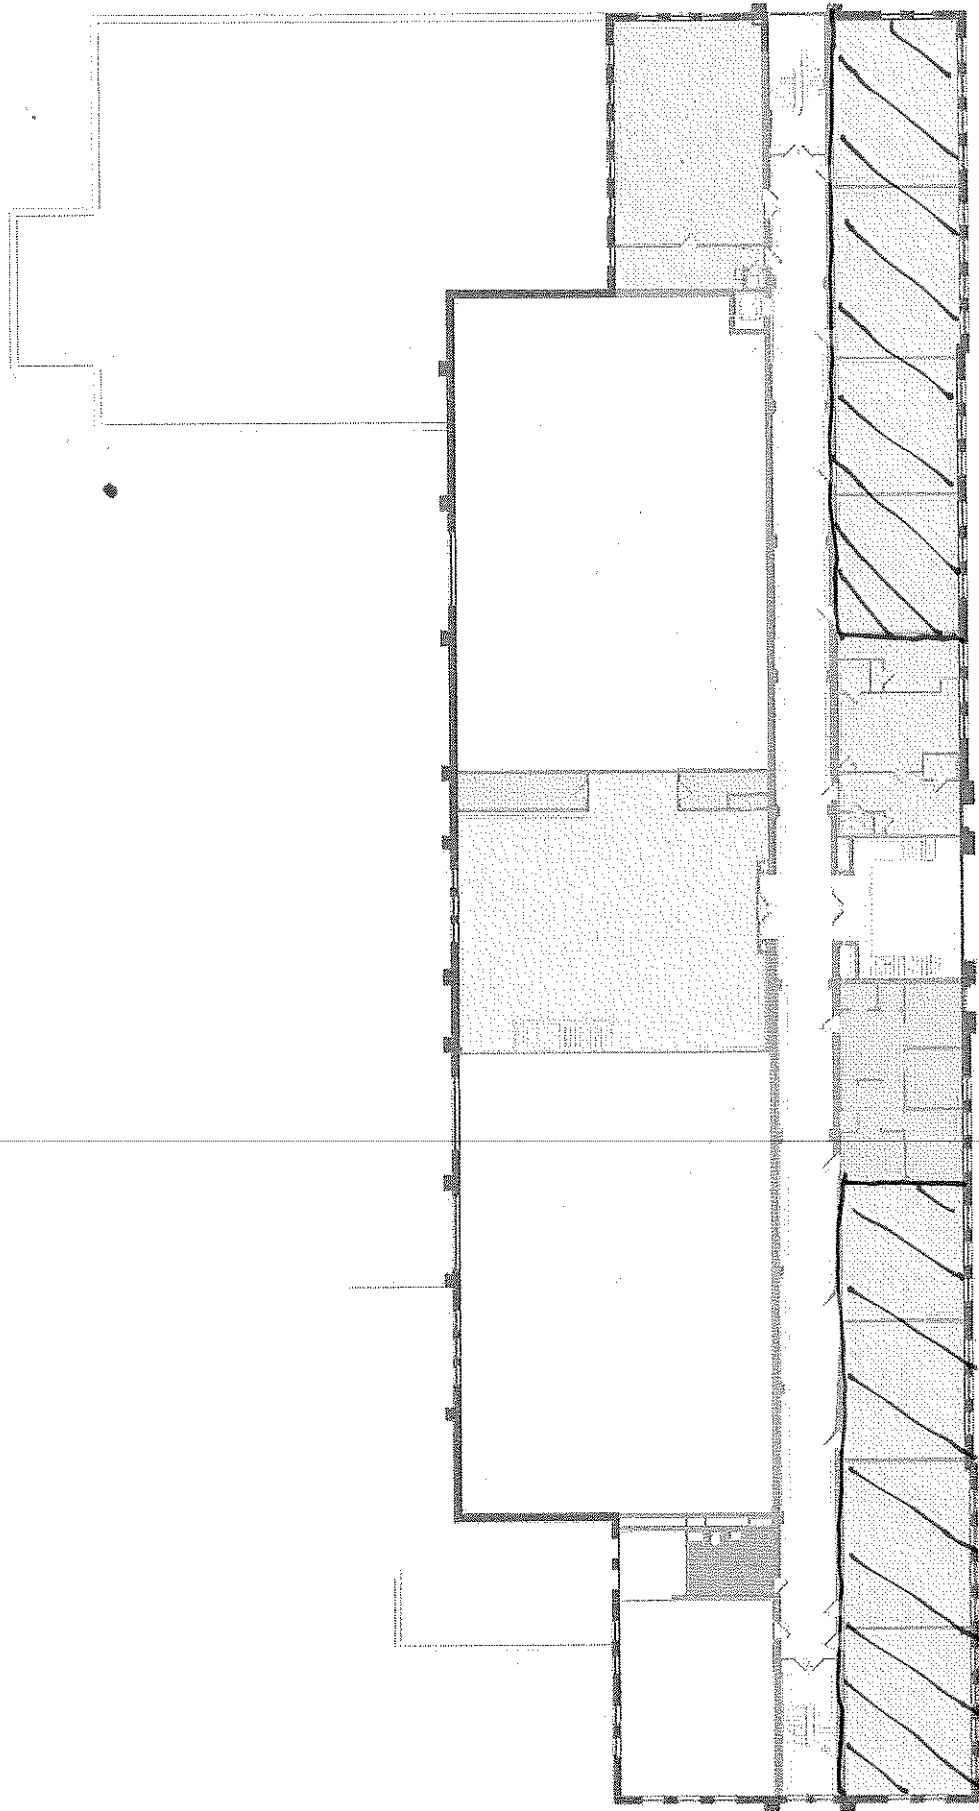
Erie county Community College (west)  
2403 West 8th Street, Erie PA 16505  
**Second Floor Level**  
NOT TO SCALE  
Prepared by: Chris Ray 1/5/24

VAT LOCATION = [diagonal hatching symbol]

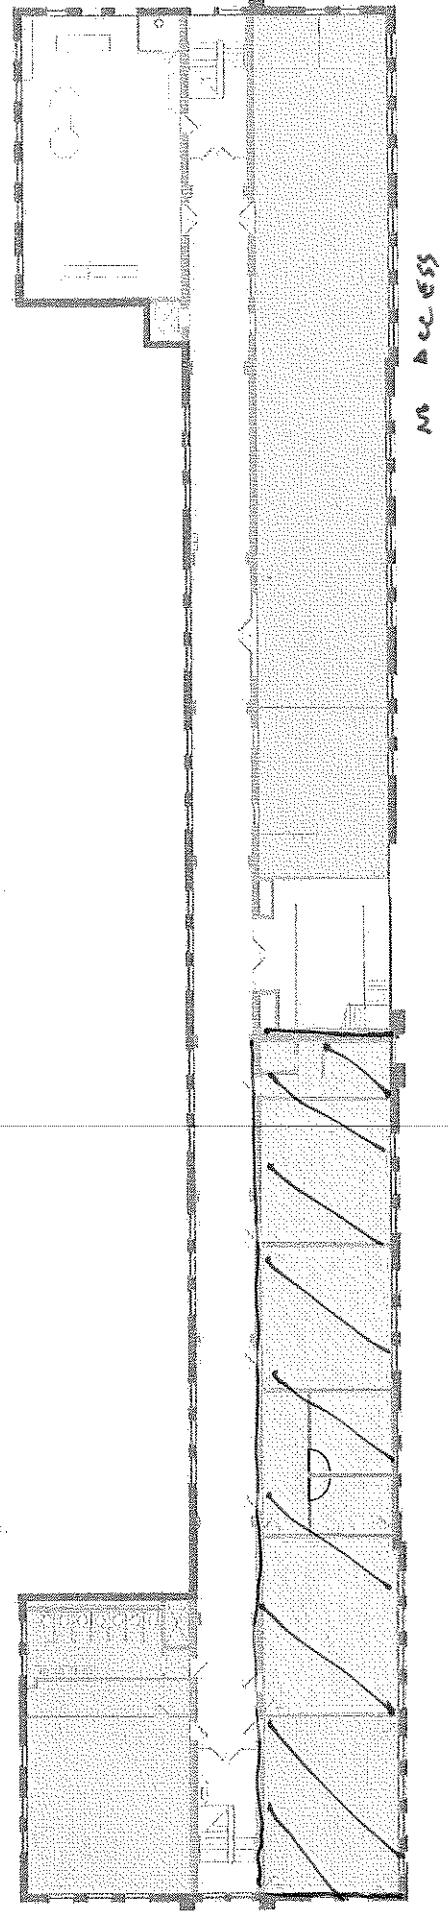
V.A.T. LOCATION
